## STABILIZATION OF LOWRY RUINS

ADRIAN S. WHITE  
AND  
DAVID A. BRETERNITZ

Mesa Verde Research Center  
University of Colorado  
Boulder, Colorado

March 1976

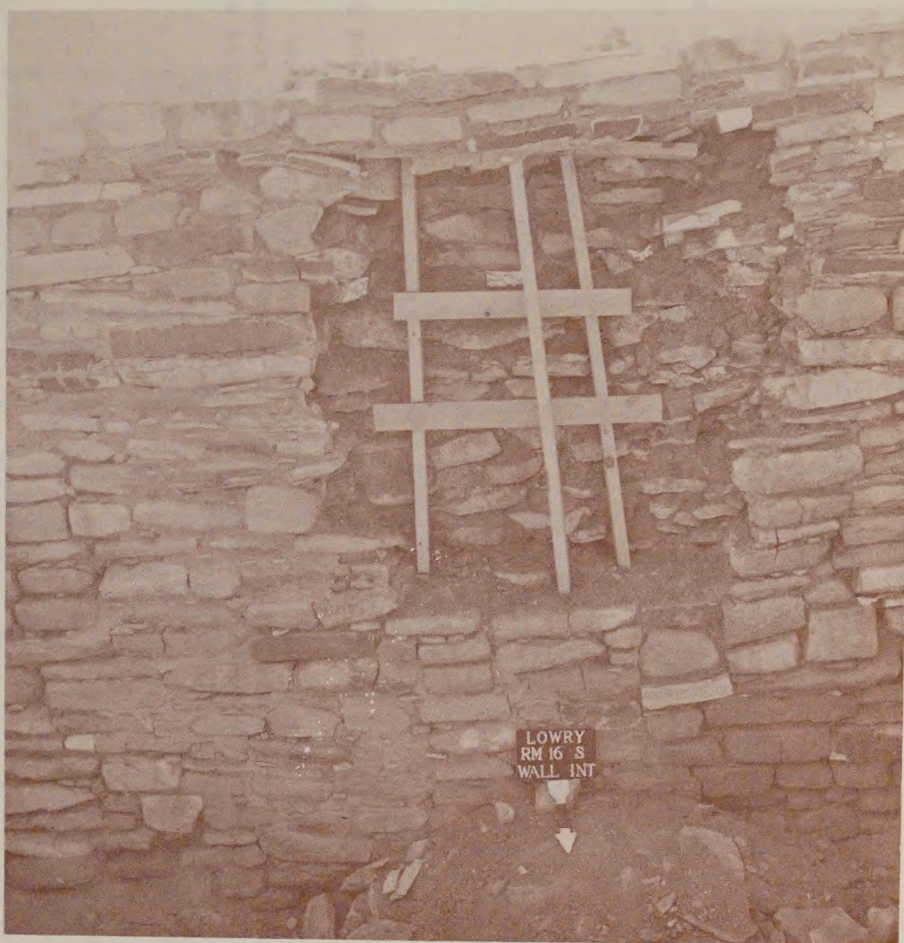
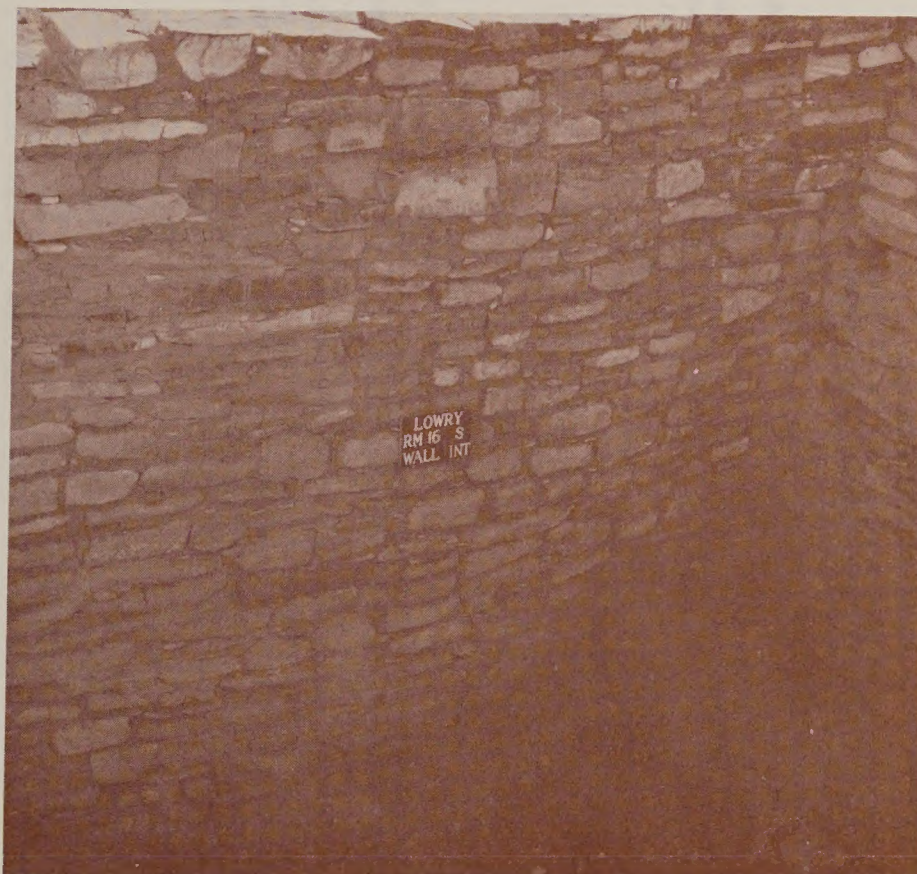
Figure 44. Room 16, south interior wall. c, wooden prop placed in the wall to support upper 2-3 courses after removal of the damaged portion; d, south view of wall after stabilization.

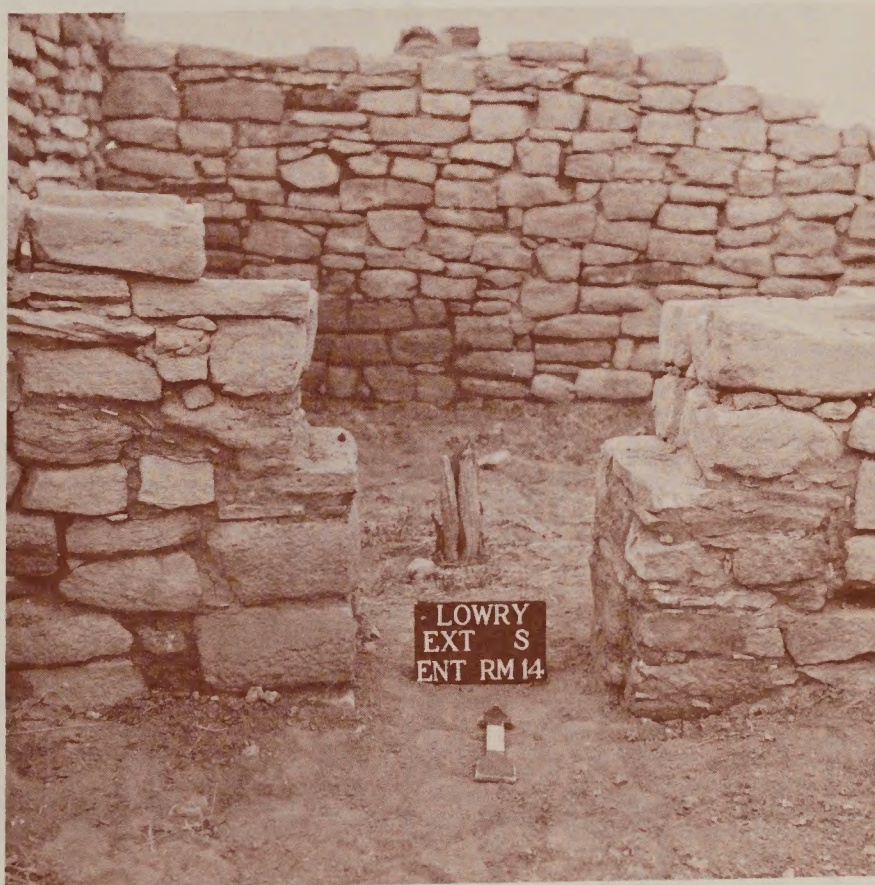
Figure 45. Room 14, south exterior entrance. a, stones were missing from both sides of the entrance and mortar was loose and cracking; b, after stones were reset and joints grouted.

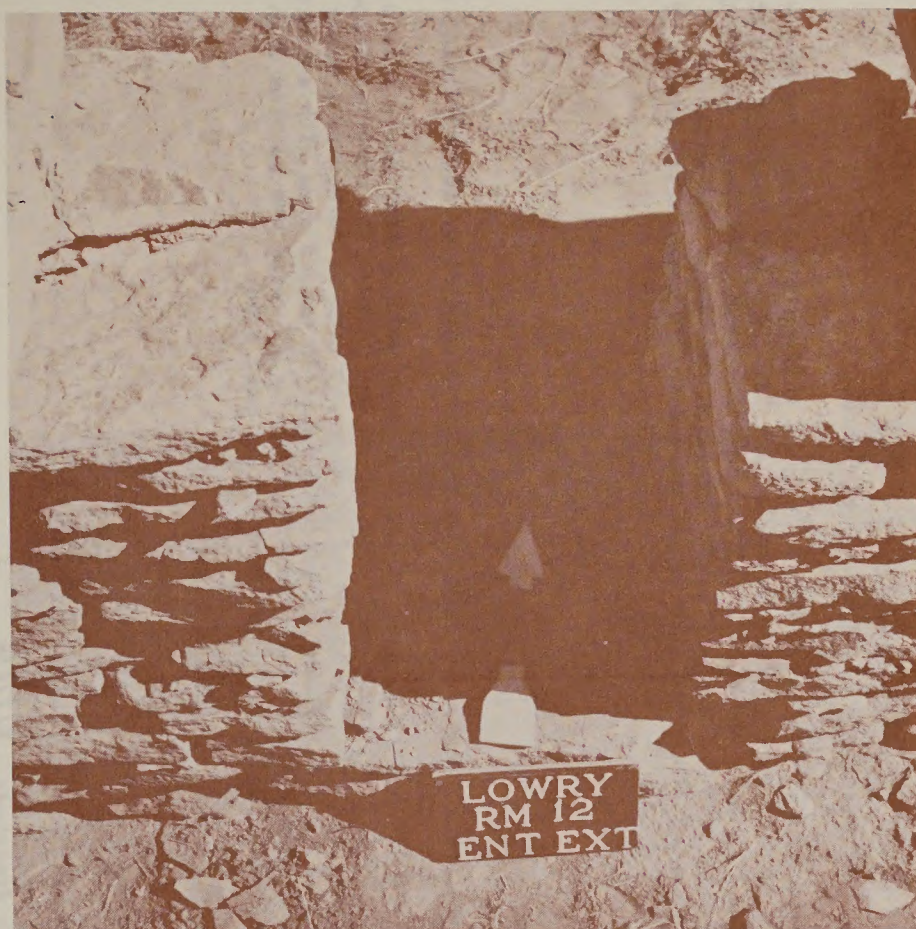
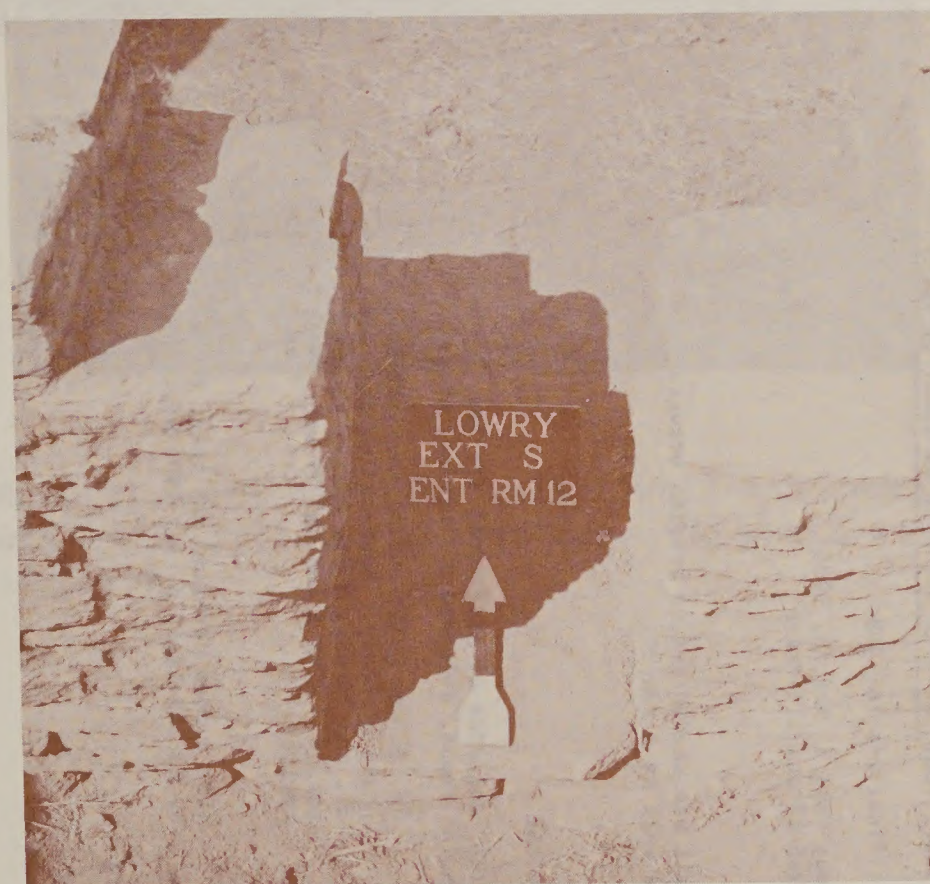
The entranceway was composed primarily of prehistoric masonry excluding upper two courses of wall which are capped and small areas which were grouted with cement. The prehistoric masonry was cracking in many areas with large chunks of mortar falling from between stones causing a general loosening of courses. Several building stones were missing leaving large gaps in walls.

Figure 46. Room 12, south exterior entrance. a, large joints resulted from erosion of mortar; b, joints were grouted with cement.

Entranceway was restored by removing all loose stones and replacing these along with those that were completely missing. Building stones were reset with a mixture of Portland Type I and II cement and Shiprock sand. All of the newly cemented area and areas involving large joints were pointed with mortar. The soil mortar was composed of two parts soil to 1 part sand.

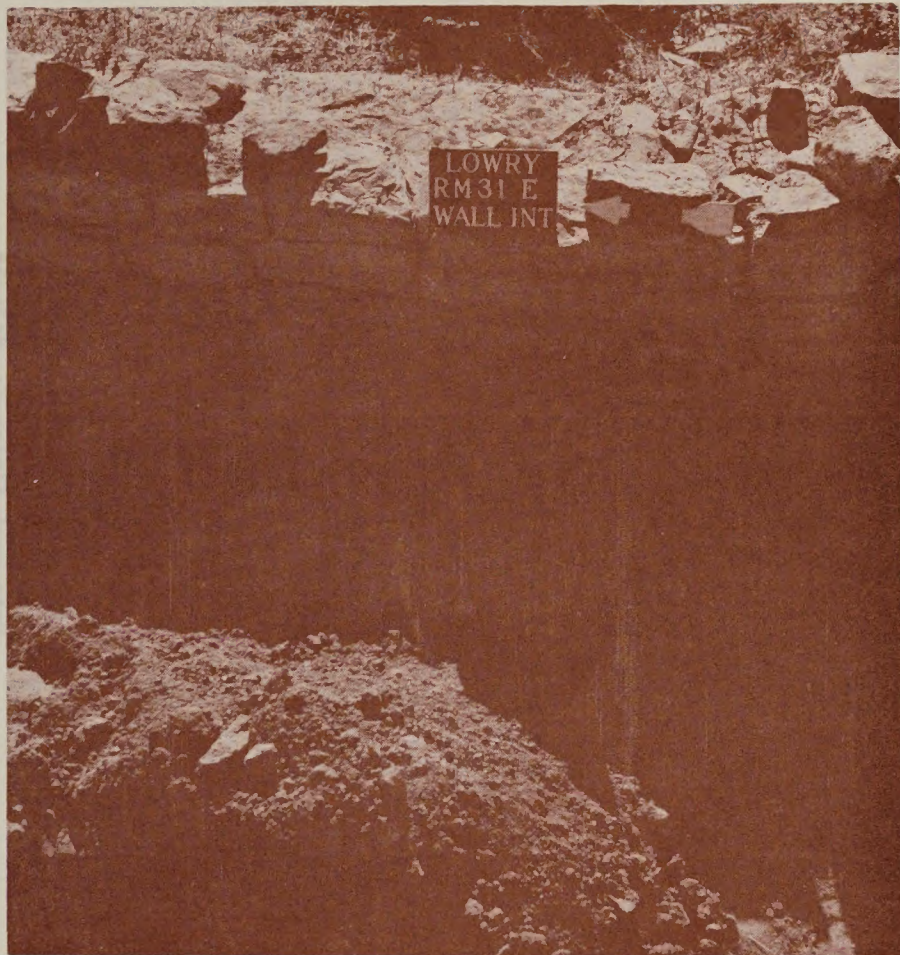
The upper two courses of wall was capped with cement. The damage to wall began below cement cap. The prehistoric wall was undermined by water flowing off the tops of walls and drainage from the surface of the room. The extent of damage involved 4-5 courses. In most areas the building stones were missing above the surface and dislodged from wall or loose below surface.

Figure 47. Room 31, east interior wall. Wall was undermined 2-3 courses beneath upper 2 course cement cap. No photo was taken before stabilization.

A trench was first dug in front of interior east wall of room 31 to locate the extent of undermining to the wall. A gap of 2-3 courses was observed below surface level of room, the length of erosion was from NE corner to 1 meter from SE corner. Old building stones were reset in eroded area with a mixture of Portland Type I and II cement and Shiprock sand. Area was pointed with a soil mortar mixture of three parts soil to 1 part sand.

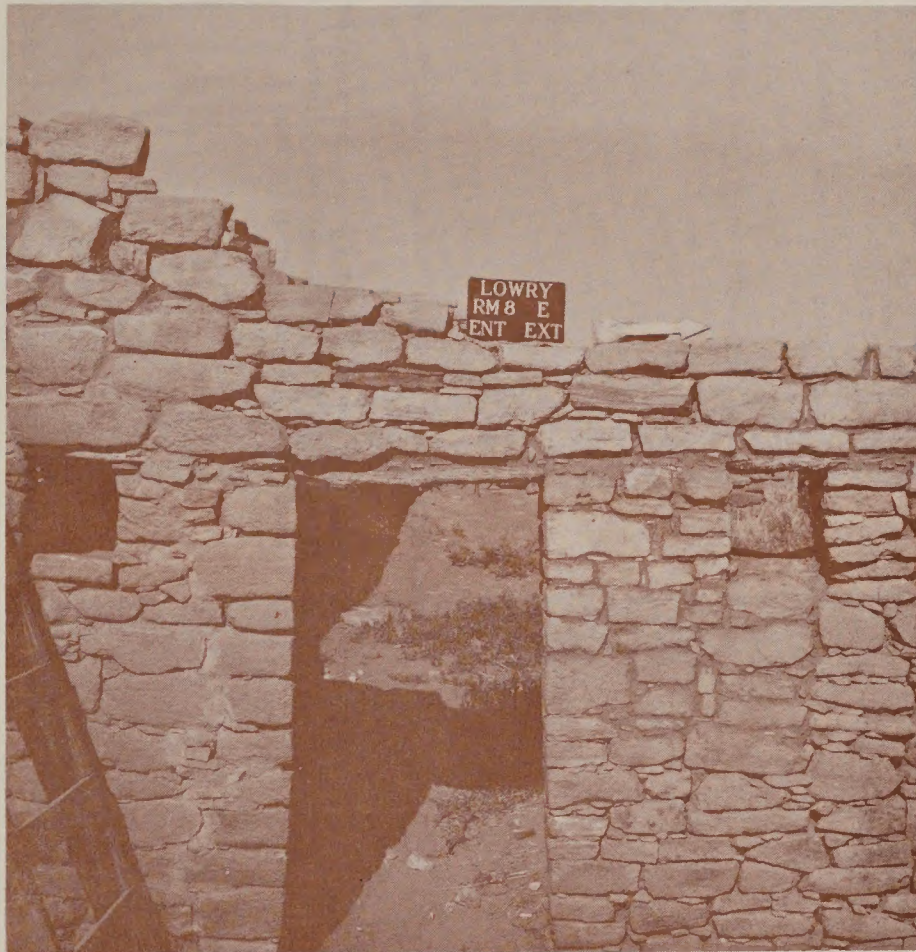
Spalling and mortar was crumbling around doorway and lintels. Windows or niches within Rm. 8 (S int. wall) had loose prehistoric mortar falling out and dislodged building stones. Lintels above these niches were loosened and needed grouting with soil mortar.

Figure 48. Room 8, east exterior entrance. All large joints of the interior and exterior wall were grouted. No photo was taken before stabilization.

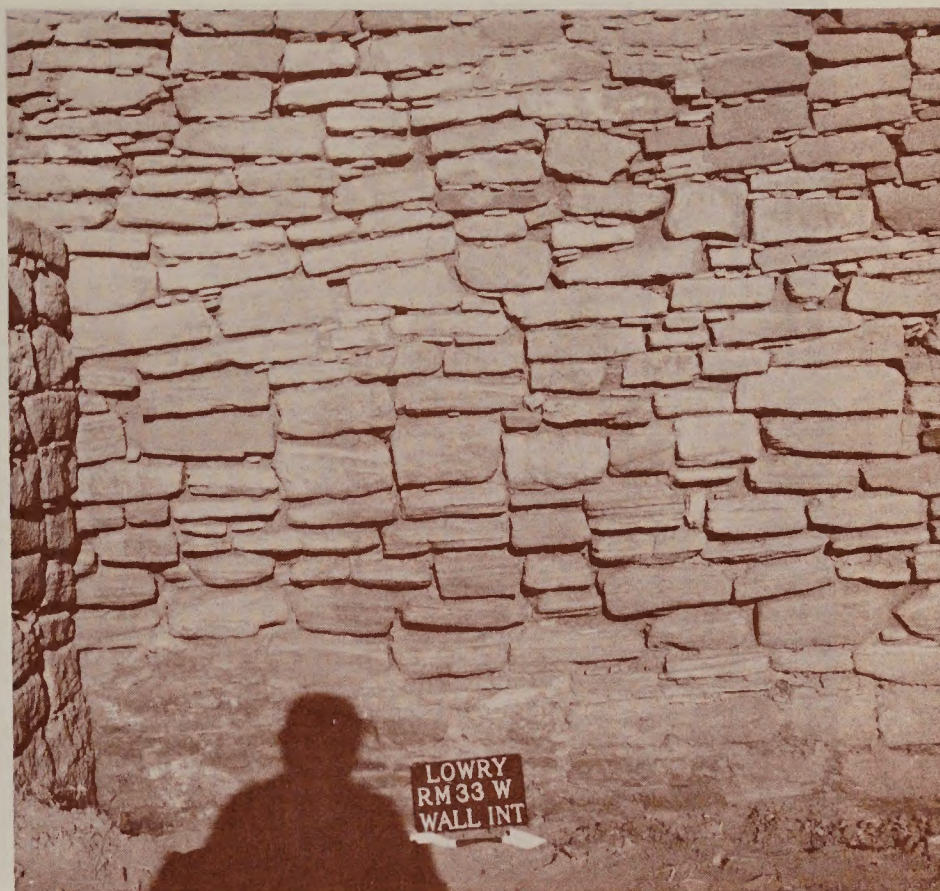
Figure 49. Room 33, north end of west interior wall. a, damage was confined to mortar crumbling from joints; excavation below ground surface showed no undermining of wall; b, soil mortar and spalls were replaced in the lower portion of the wall.

Pointing and replacing of spalls was limited to lower nine courses of wall. The entire length of wall N-S was pointed. A soil mortar of two parts soil to 1 part sand was used for pointing.

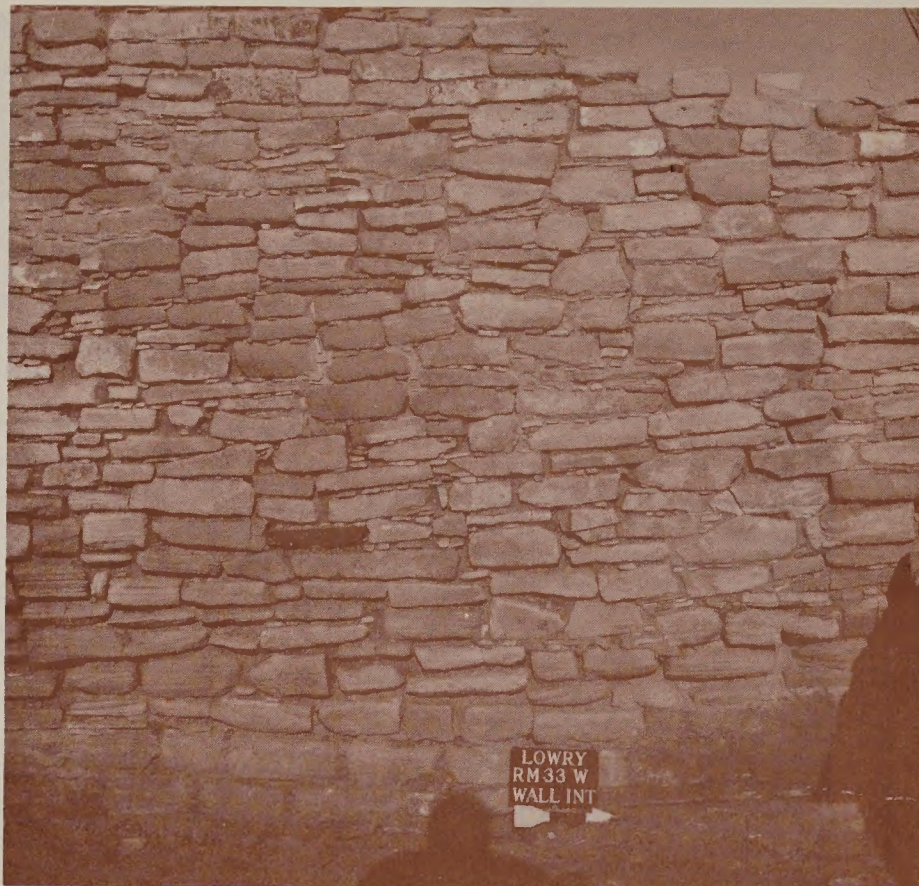
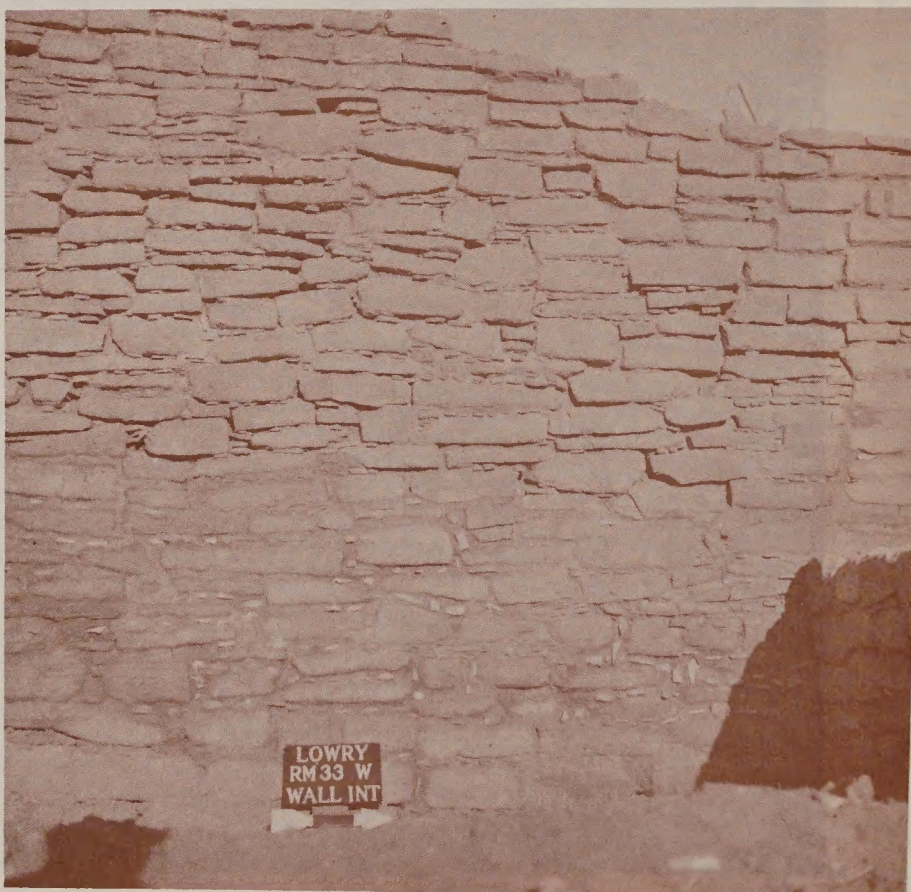
Figure 49. Room 33, south end of the west interior wall. c, damage was confined to mortar crumbling from joints; excavation below ground surface showed no undermining of wall; b, soil mortar and spalls were replaced in the lower portion of the wall.

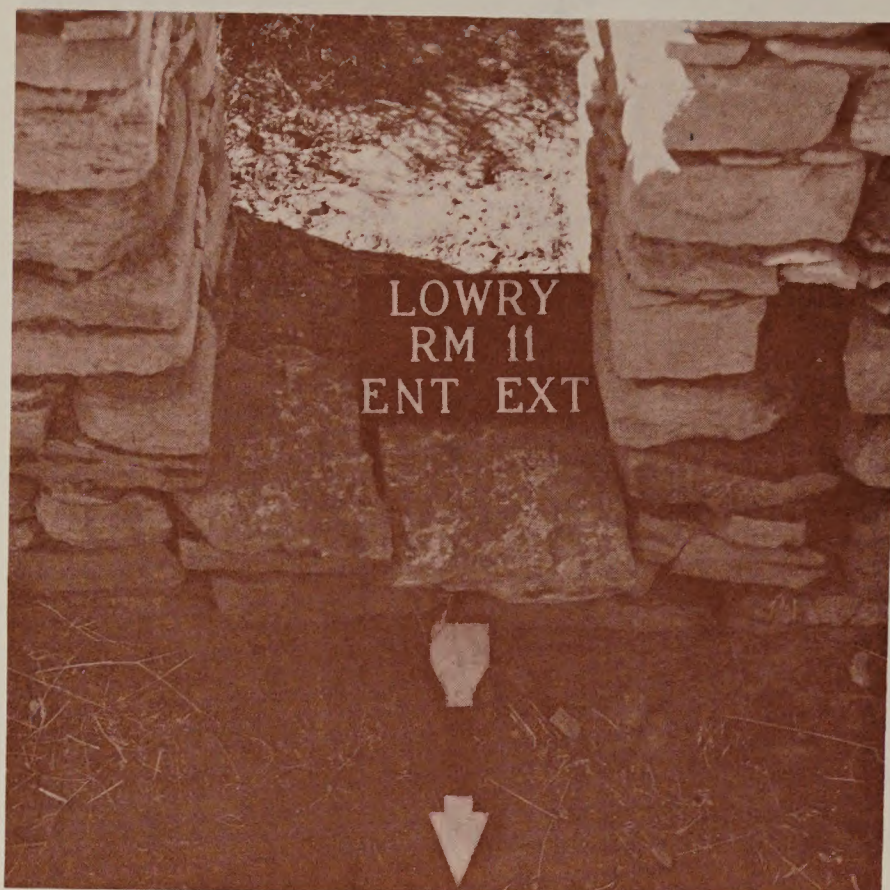
- A. N Ent. to Rm. 11 - Building stones composing step into Room 11 were loose from cement (1966-67 Al Lancaster) and small area W of Ent. had gaping hole where one stone had fallen out.  
B. E Entrance to Rm. 10 - Large building stone composing S end of 1st upper course of bench portion of T doorway was missing.  
C. Several small patches were made on the W int. wall of Room 10 where bldg. stones were dislodged from wall.

Figure 50. Room 11, north exterior entrance. a, step was loose, a stone was missing from the west side of the entrance and mortar was cracking from the joints; b, after stabilization.

- A. North Ent. to Room 11 - Old stone was reused with a mixture of Shiprock sand and Portland Type I cement. A soil mortar mixture of 2 parts soil to 1 part sand was used to point up newly cemented areas.  
B. E ent. to Room 10 - Old stone was reshaped and reused with a mixture of Shiprock sand and Portland Type I cement. A soil mortar mixture of two parts soil to 1 part sand was used to point up newly cemented areas.  
C. Small patches in Room 10 were stabilized with small amounts of cement and large chunk type spalls. A soil mortar mixture of three parts soil to one part sand was used to point up newly cemented areas.

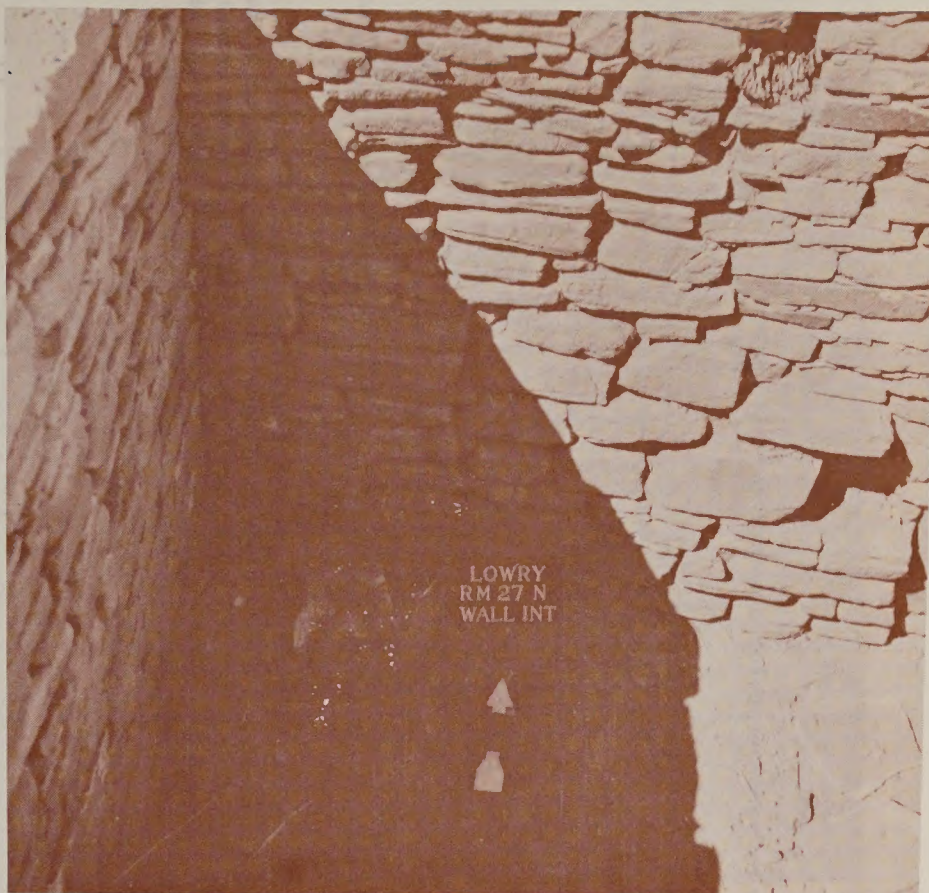
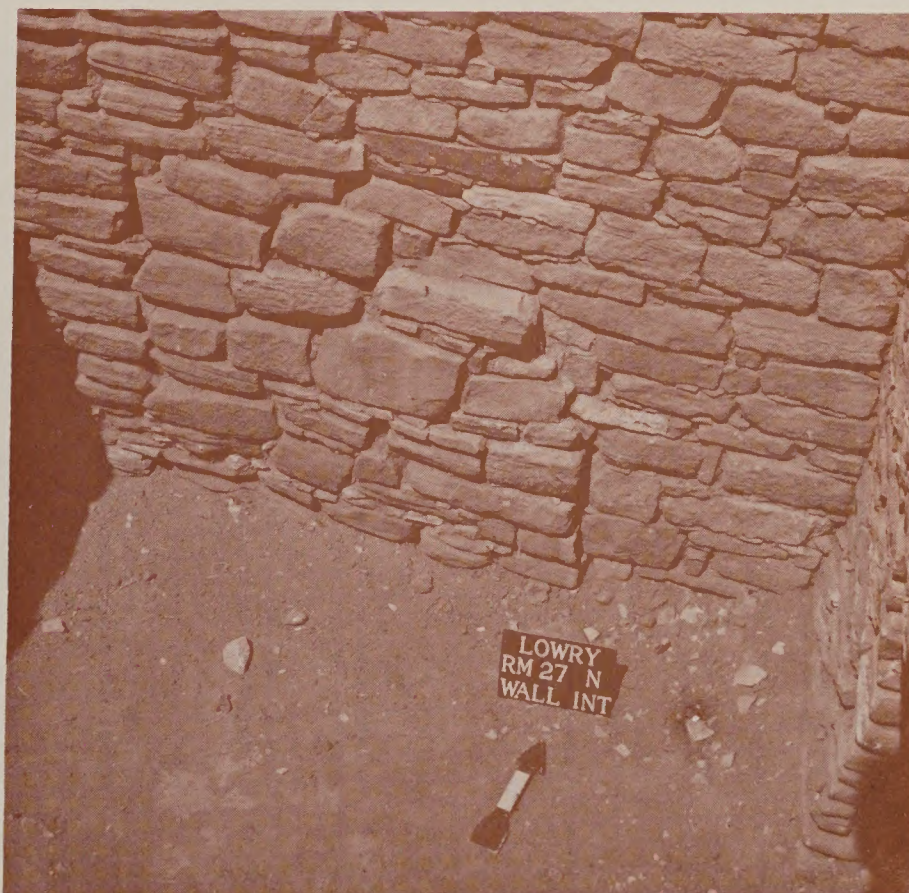
The N wall of Room 27 was being undermined by the loosening of stones and crumbling of soil mortar beneath areas laid in cement.

Figure 52. Room 27, north interior wall. a, several stones were missing and the mortar was crumbling beneath cement cap; b, stones were reset and the joints were grouted.

In the original stabilization in 1966 when this wall was offset an unstable condition developed due to the high ground surface of the area to the North. A small hole developed in the wall in the area of the offset. This hole was enlarged into a drainage hole to drain off water to the North which had been excavated in 1974. All loose stones were removed from the wall and reset with a mixture of Portland Type I and II cement and Shiprock sand.

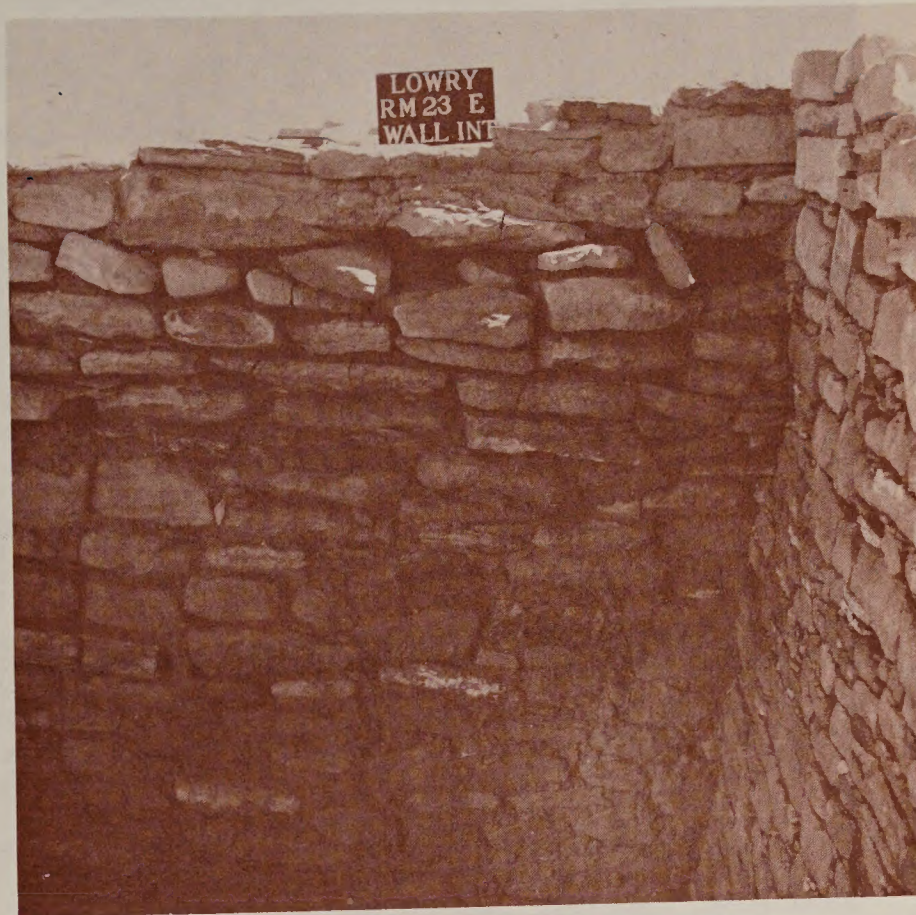
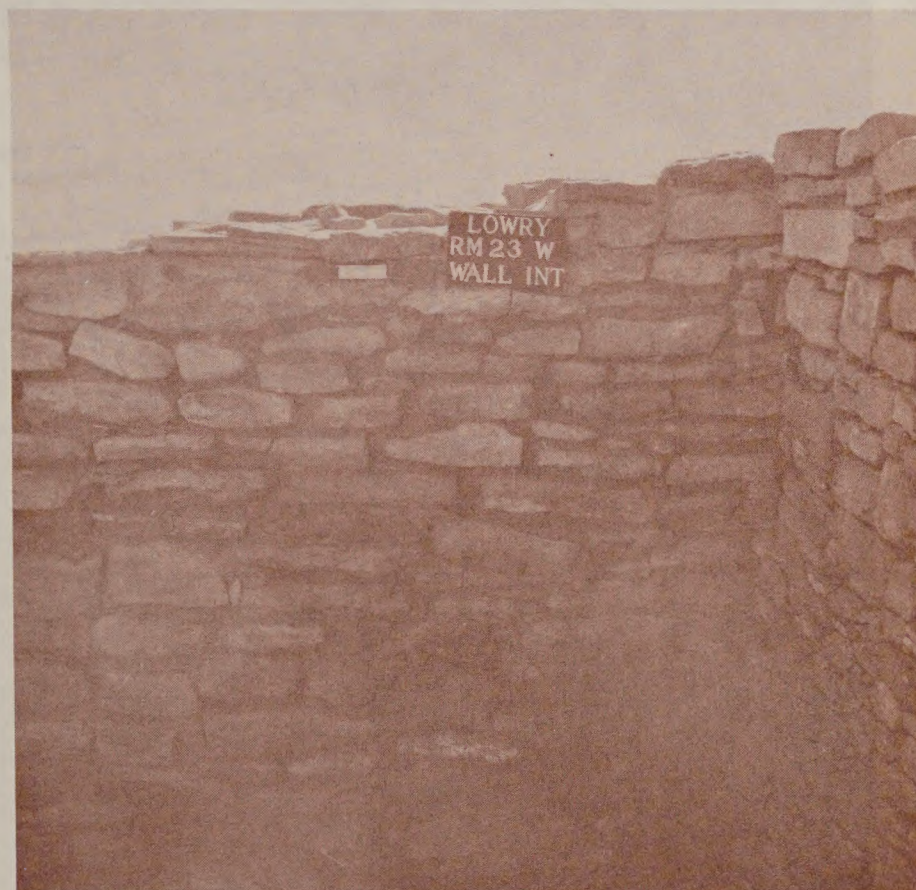
Figure 53. Room 23, east interior wall. a, masonry immediately beneath the cap was eroding; b, view after stabilization; photo board is mislabeled.

The area on the east wall below cement cap was cleaned out with all loose building stones and mortar removed. These stones were reset with a mixture of Portland Type I and II cement and Shiprock sand. All newly cemented joints were pointed with a soil mortar mixture of three parts soil to one part sand. A large joint on the north wall was grouted with cement.

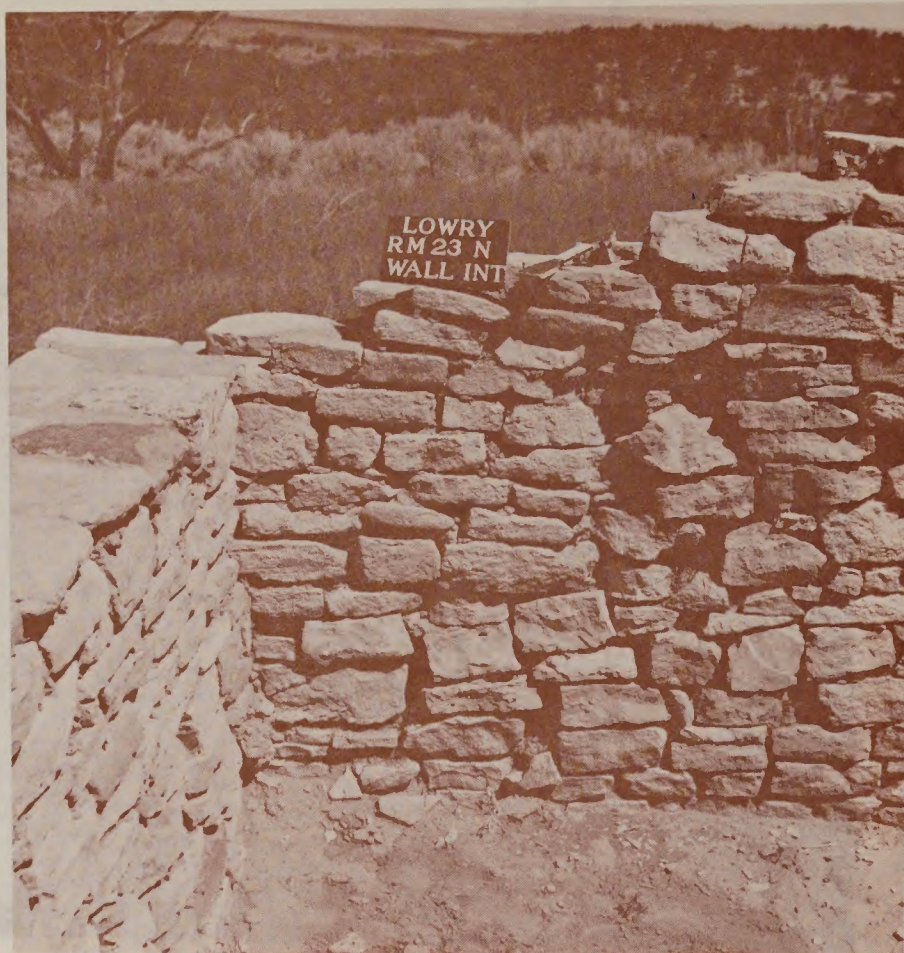
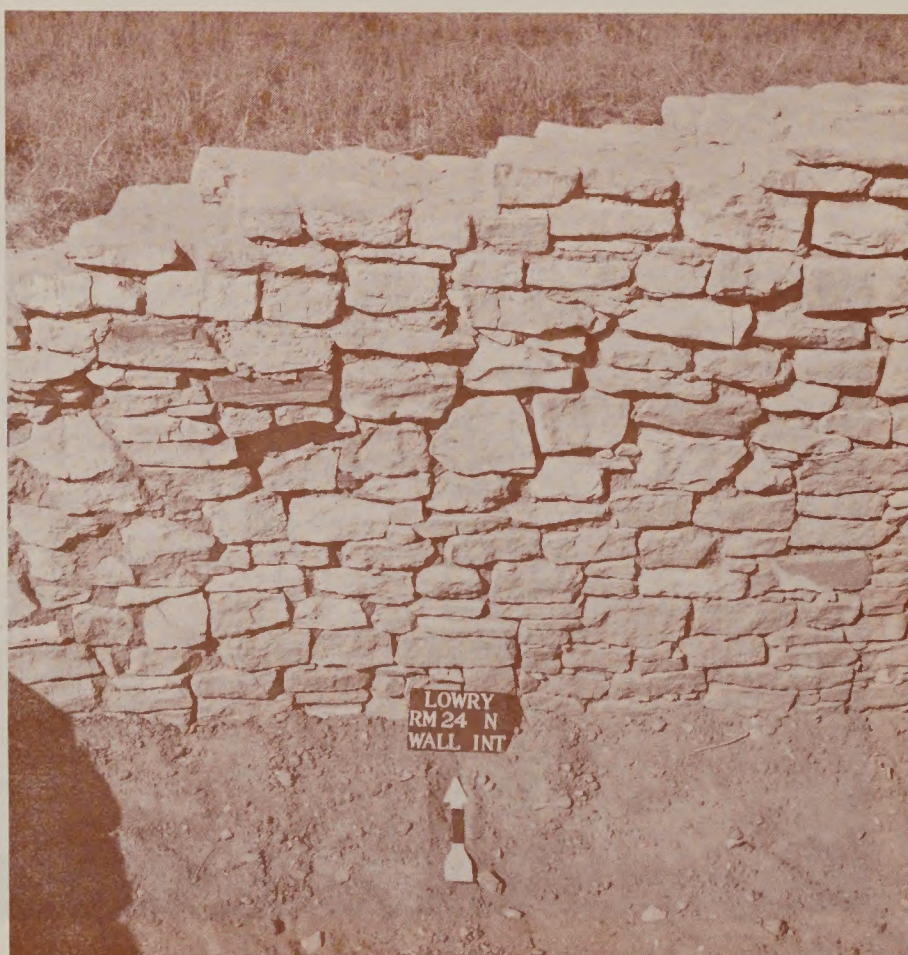
Figure 54. Room 23, north interior wall. a, several areas of the wall had large gaps resulting from crumbling mortar; b, after stabilization; Photo board is mislabeled.

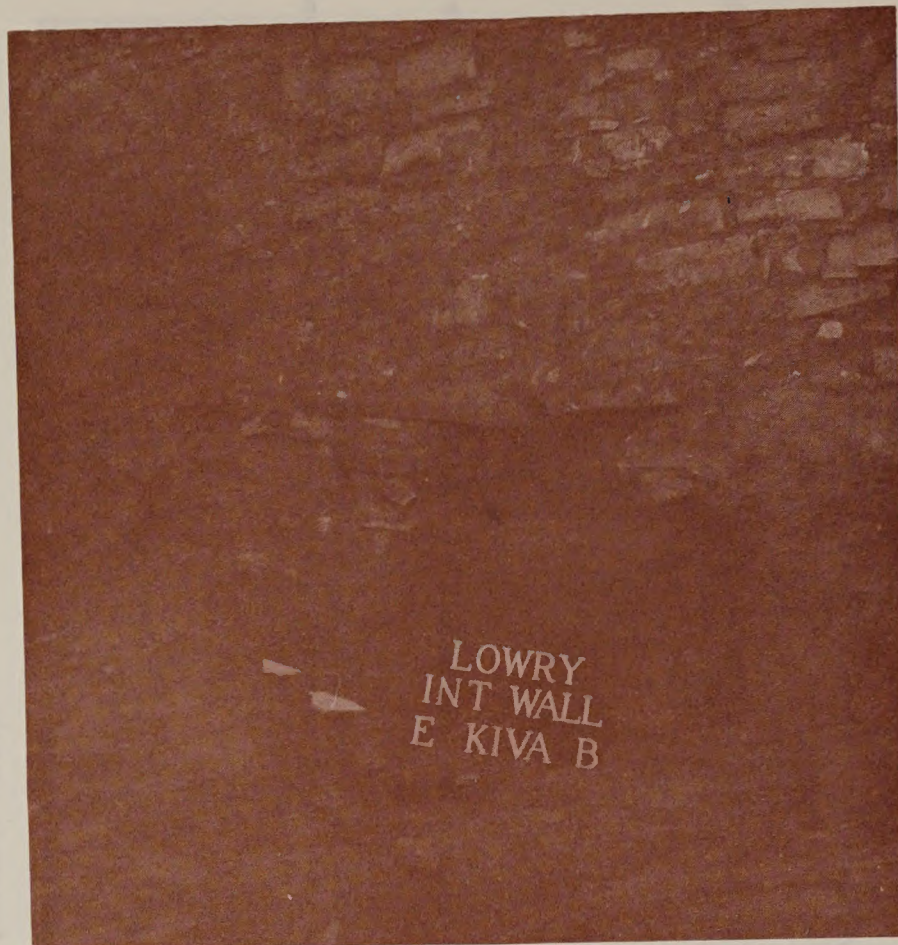
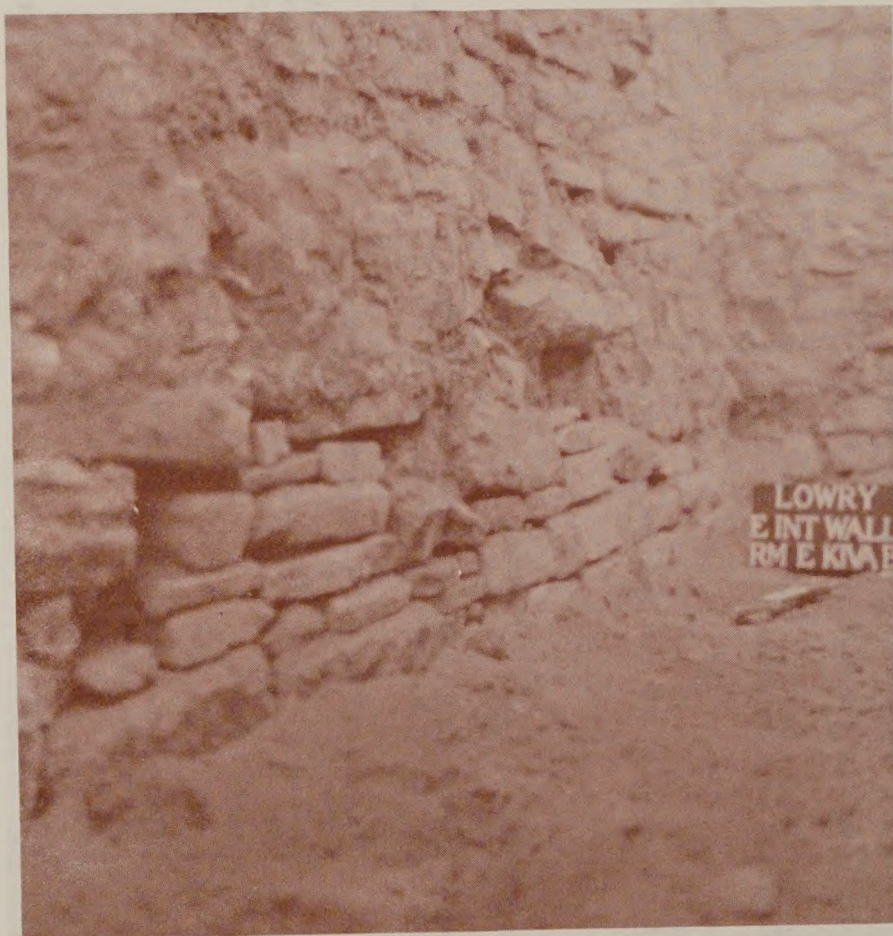
A cap of four courses was rebuilt in 1966. The area of erosion was below this cap where prehistoric masonry is still present. A portion of the original veneer was eroding from wall. The prehistoric soil mortar was soft and crumbling out in chunks. Along with veneer a new foundation had to be rebuilt for wall since stones were loose at the base of wall.

Wall was being undermined by water beneath cement cap creating an unstable condition for entire wall.

Figure 55. Space east of Kiva B (unnumbered), east interior wall. a, wall was undermined in large area; b, missing and loosened stones were reset.

All loose stones were removed along with cracking soil mortar. Building stones were reset in veneer and at the base of wall with a mixture of Portland Type I and II and Shiprock sand.

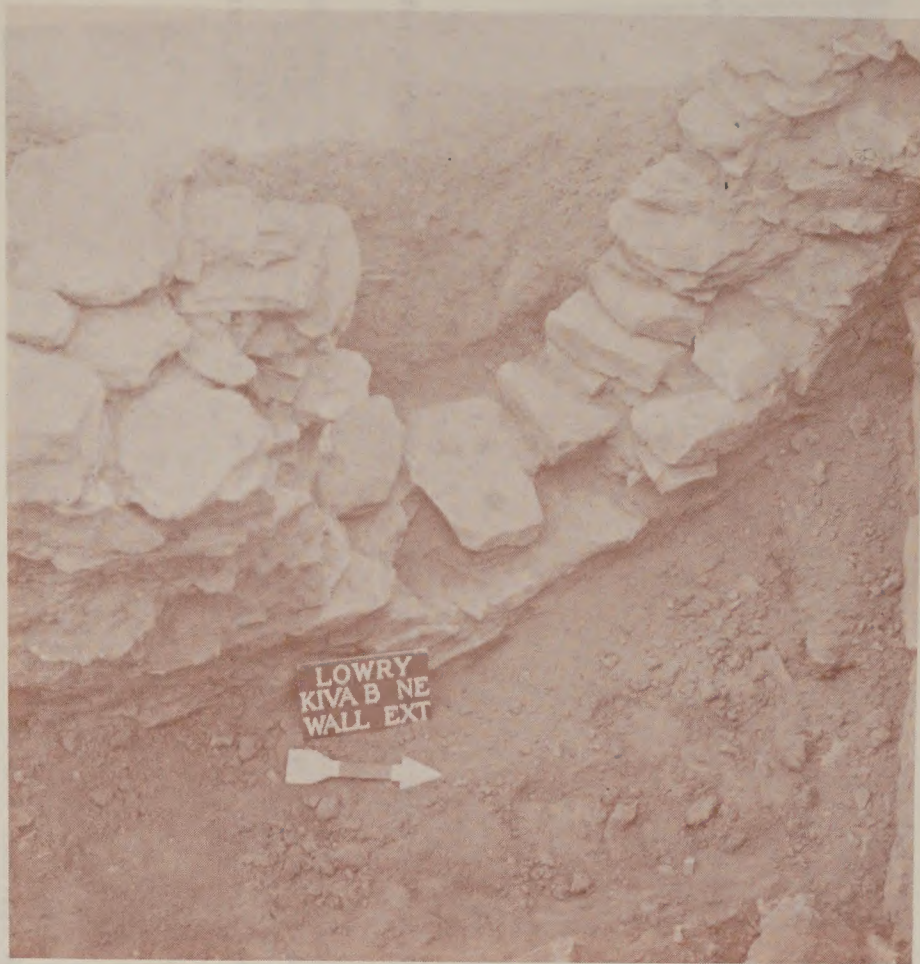
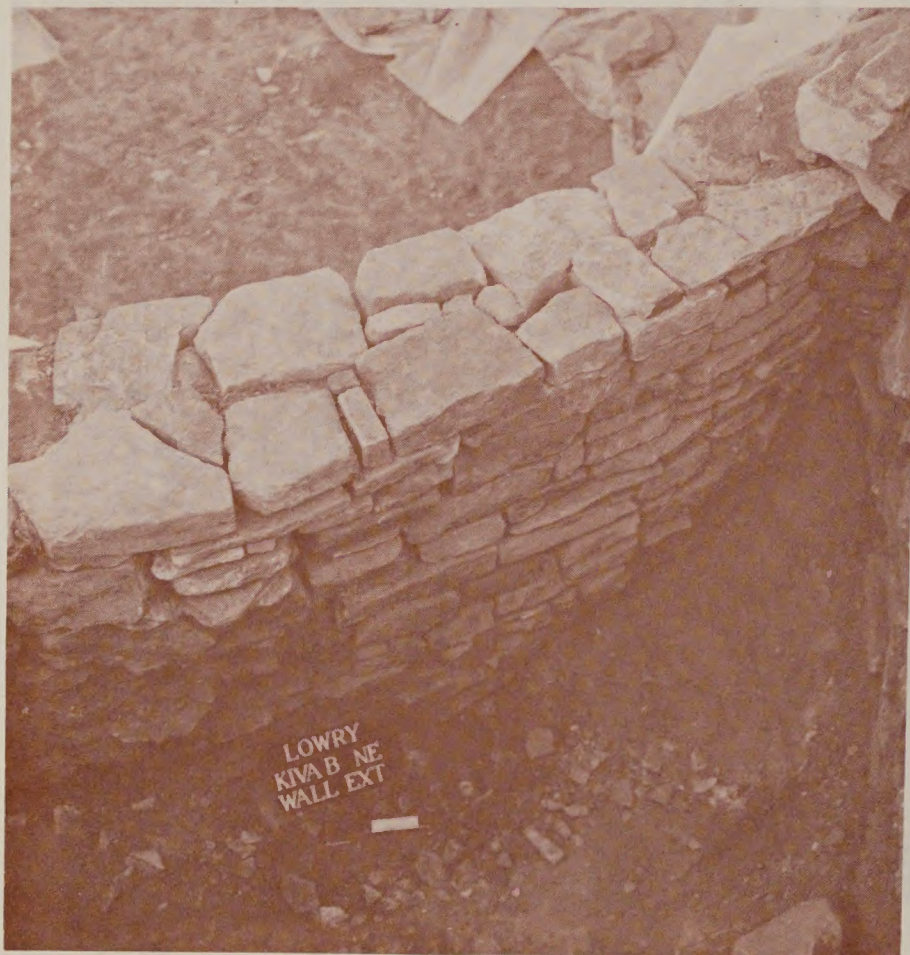
Figure 56. Kiva B, northeast wall. a, stones were loosened throughout the thickness of the wall; b, wall was rebuilt to an even level to provide a foundation for roof.

The entire thickness of wall was taken down 6-7 courses. All loose stones and crumbling of loose mortar was taken out. Building stones were reset with a mixture of Portland Type I and II cement and Shiprock sand. All cemented joints were pointed with a soft mortar mixture of four parts soil to one part sand.

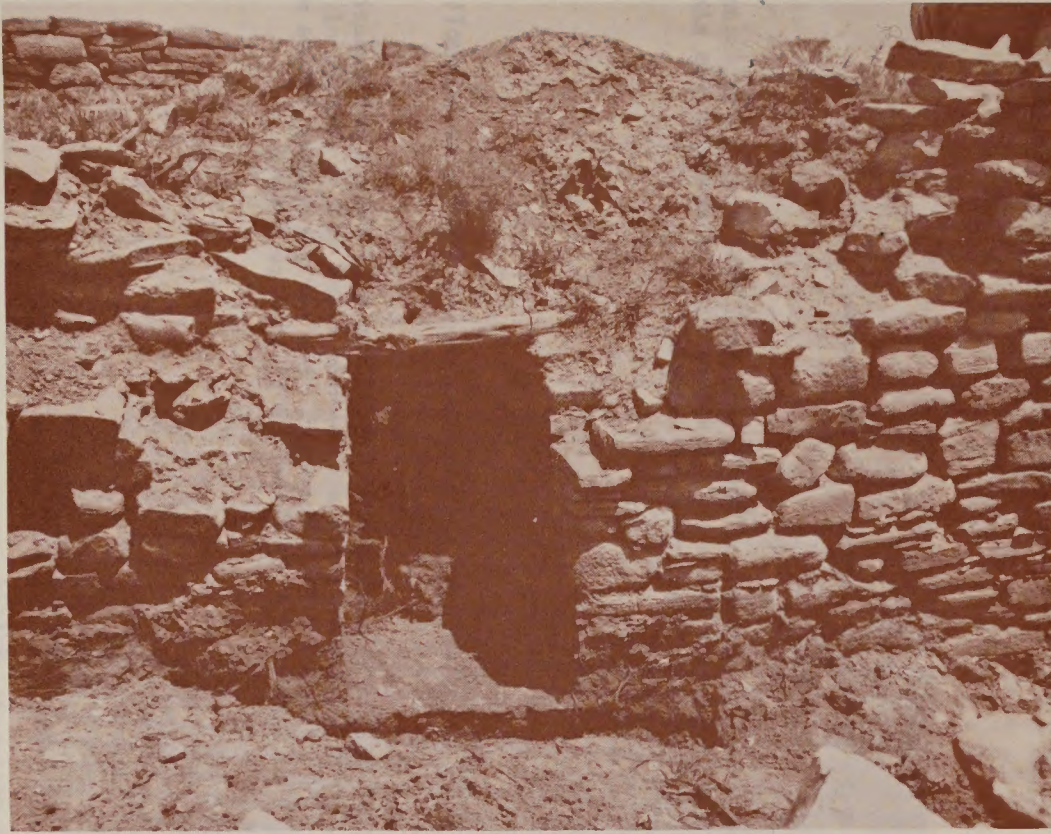
Figure 58. Room 21, east interior entrance. a, before stabilization in 1966; b, rodent hole on exterior side that probably caused damage to the interior side.

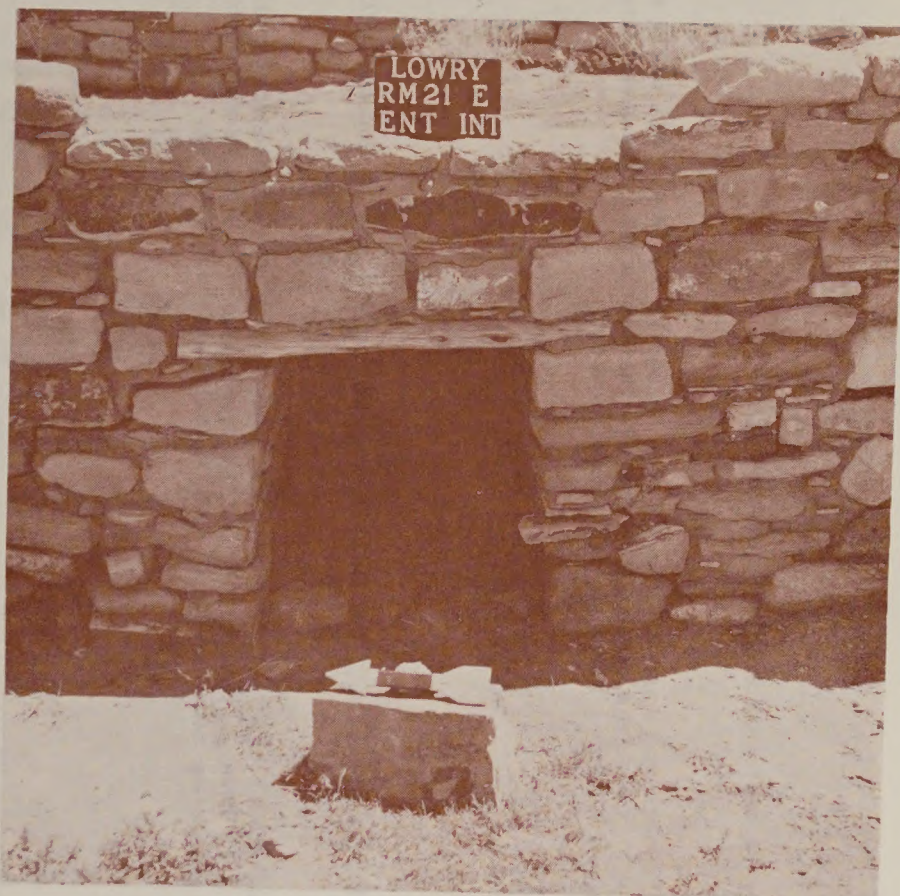
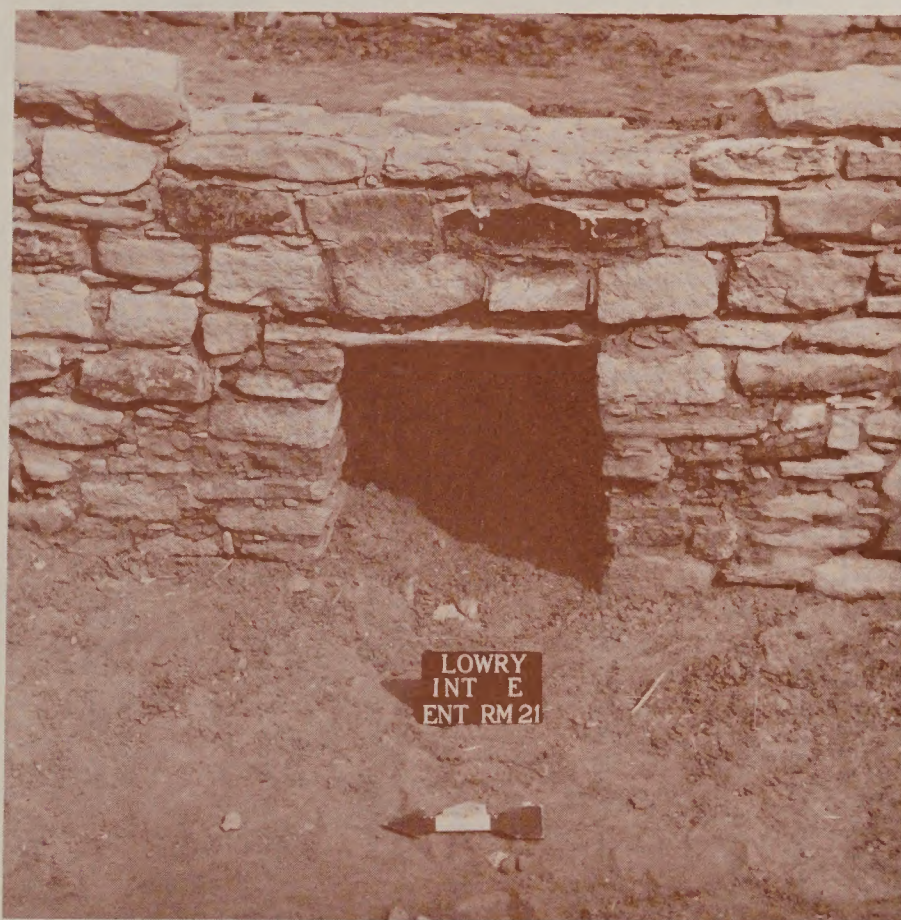
Figure 58. Room 21, east interior entrance. c, a large crack extended from the lintel to ground surface and stones were loose to either side of the entrance; d, after stabilization.
